SPE 109882

## Mad Dog Slot W1 Tubing Deformation Failure Analysis

P. D. Pattillo, SPE, BP America; U. B. Sathuvalli, SPE, and S. M. Rahman, SPE, Blade Energy Partners; H. H. Prewett, SPE, S. P. Carmichael, SPE, and R. Wydrinski, SPE, BP America

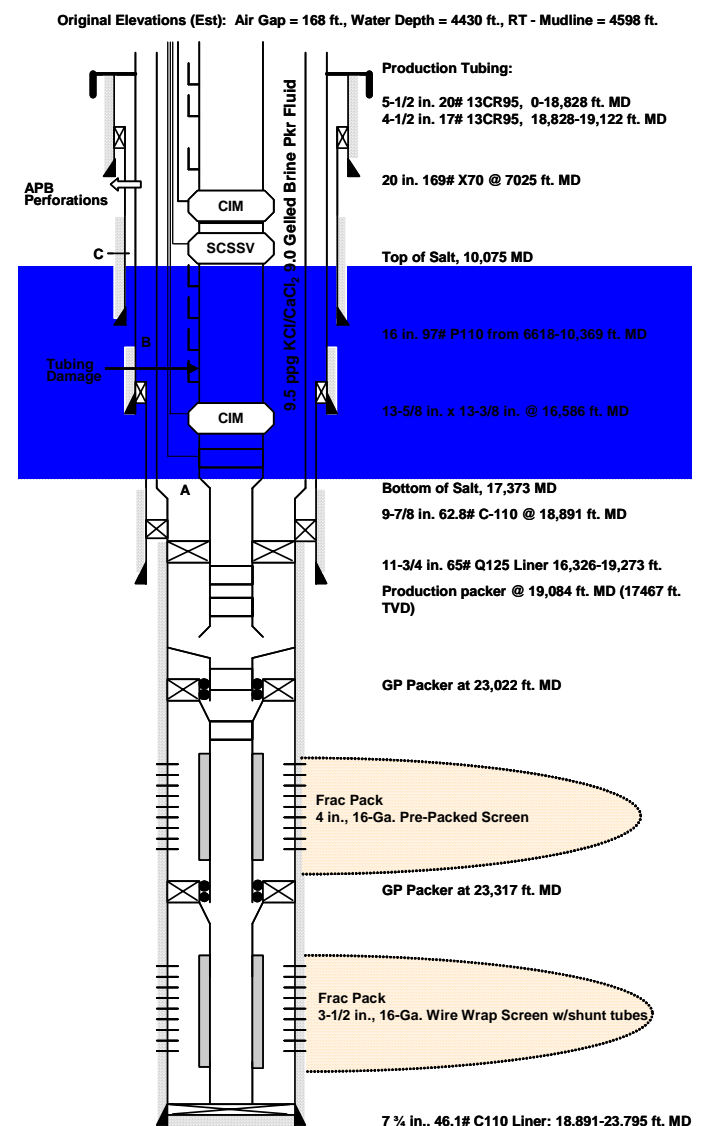
Fig. 1 – Schematic of Mad Dog Slot W1 Wellbore

**Terminology.** Fig. 1 is an overview schematic of Well W1, illustrating various well components to be addressed in the
